Sailors and Marines Reducing Mishaps **BRAVGO Zulu**

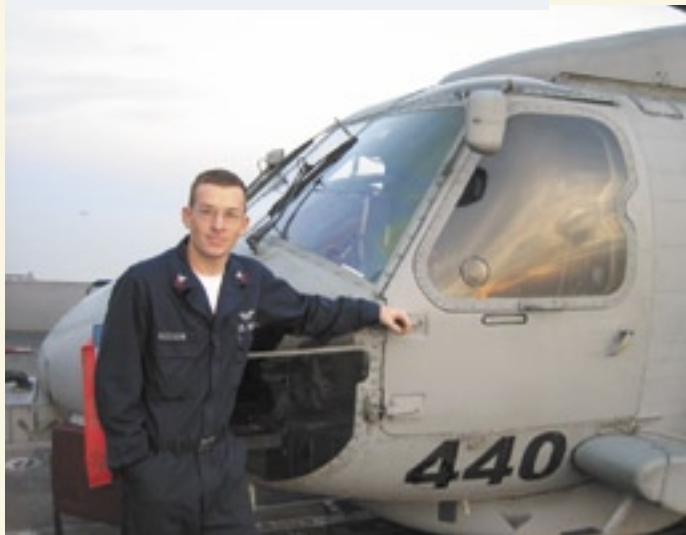
AD1(AW) Mark Hudson
HSL-44 Det 8

Petty Officer Hudson discovered fuel leaking from the No. 1 engine of Magnum 440 during a hot-section wash. Further inspection revealed a missing O-ring packing in an area that leads from the overspeed and drain valve into the accessory gearbox, causing fuel to leak during normal operation. Petty Officer Hudson's keen attention to detail allowed him to initiate timely repairs and break the mishap chain, making MAGNUM 440 immediately available for the tasking from the Carrier Strike Group deployed in the Arabian Gulf.

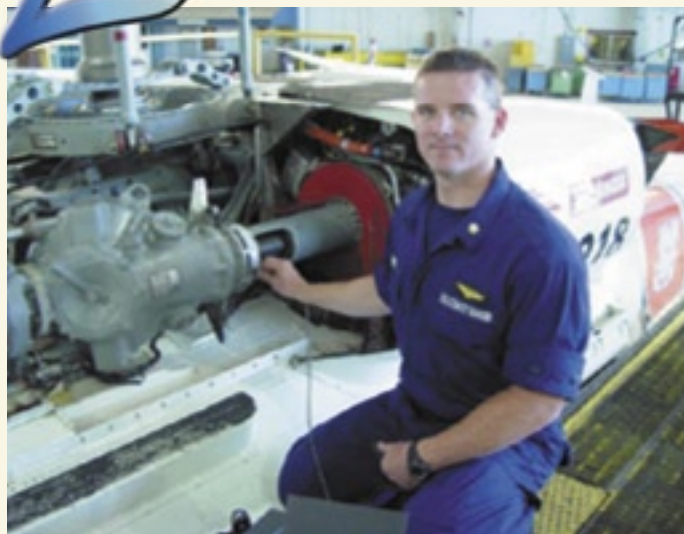
PO2 Reagan Payne
USCG Air Station, Clearwater, Fla.

While in support of recovery operations for Hurricanes Katrina and Rita, Petty Officer Payne was completing an hourly engine inspection on a Sikorsky HH-60J search and rescue helicopter. Using a state-of-the-art borescope, Petty Officer Payne found several hairline cracks in the No. 1 engine high-speed shaft flex pack.

Petty Officer Payne's strict attention to detail most certainly prevented a major catastrophic failure of the No. 1 engine high-speed shaft, avoiding possible damage to the airframe and, most importantly, averting a potential mishap.

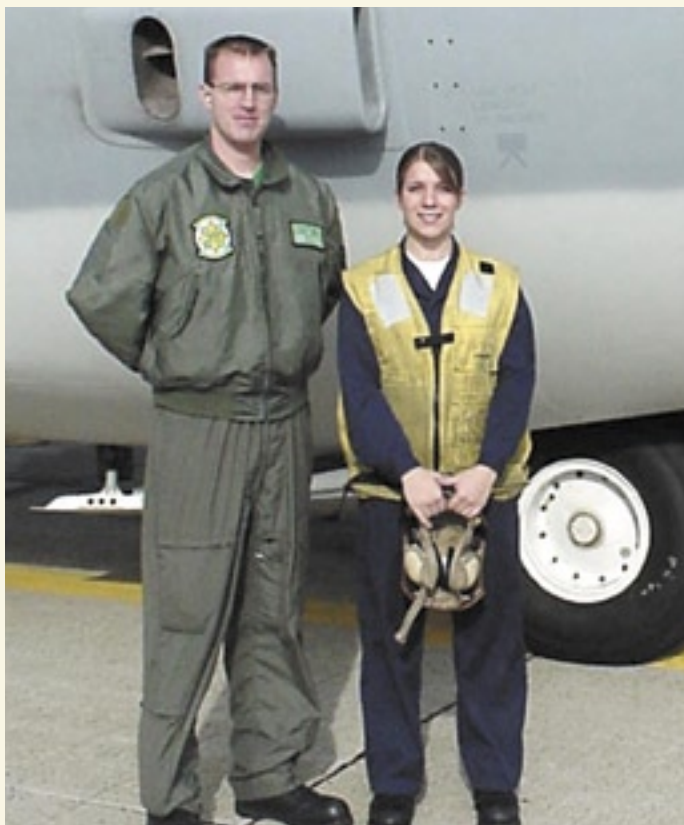
AM2 (NAC) Brian Gillespie and AM3 Kathryn Cayer
VR-62

During engine start-up for a routine training mission, the second loadmaster, Petty Officer Gillespie, and plane captain, Petty Officer Cayer, were positioned in front of the aircraft to observe the start. They noticed the inboard, life-raft-compartment door on top of the starboard wing momentarily spring open and then return to a normal position. They immediately notified the aircraft commander, who terminated the start.

Upon further investigation, squadron personnel found that the life-raft-compartment latches had released, allowing the propeller wash to blow open the door.

Petty Officers Gillespie and Cayer caught a fleeting glimpse of a problem that could have resulted in an in-flight deployment of the life raft, which could have jammed the flight controls and caused serious damage to aircraft and the possible loss of the aircrew.

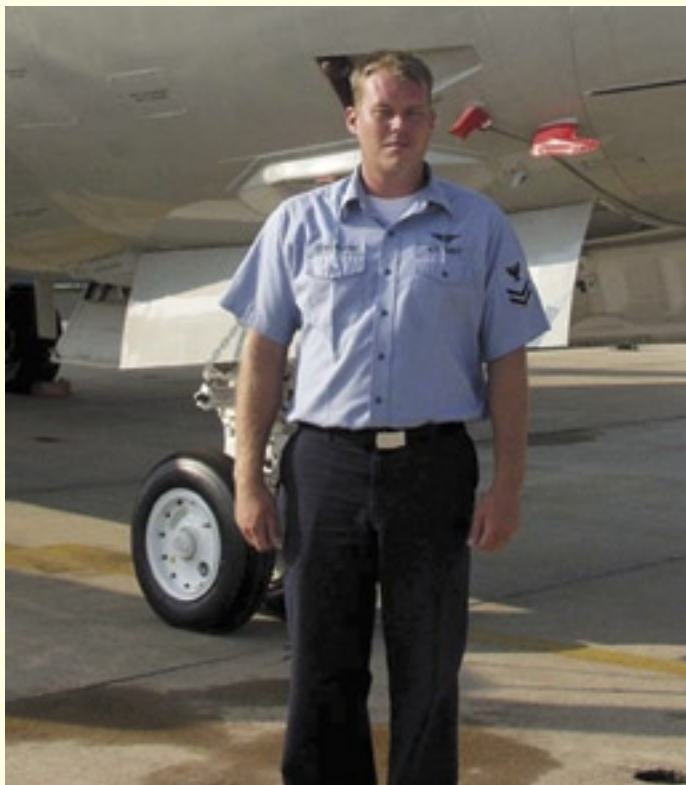
**AT2(AW) Shannon Strickland
VX-20**

A P-3 was sent on a logistics mission to deliver mission-capable parts for a detached squadron aircraft. Upon arrival and after securing the engines, the ground crew began to download the parts and associated gear.

Petty Officer Strickland noticed hot brakes on the port side of the aircraft, immediately stopped the download evolution, and then cleared everyone away from the explosive hazard that existed.

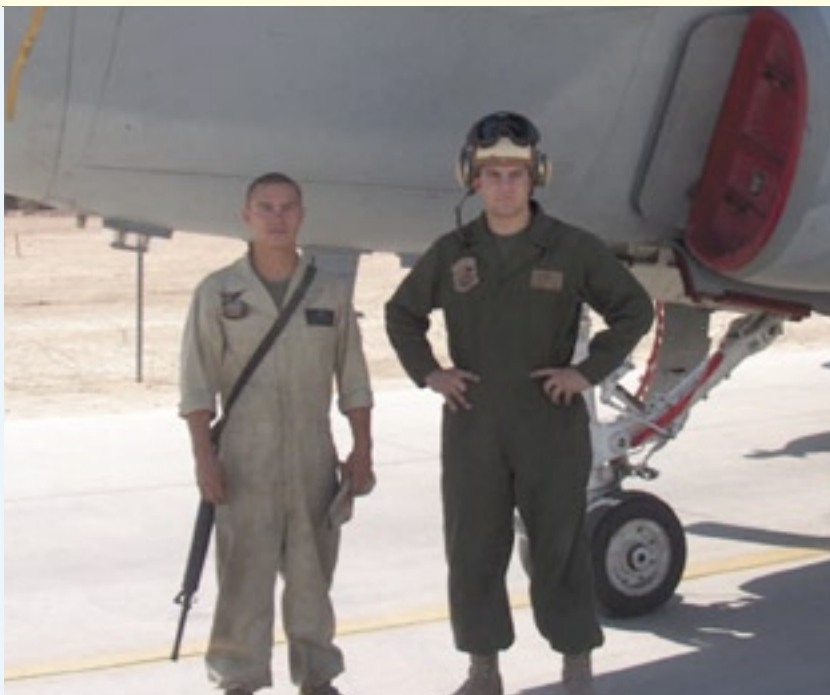
**Sgt. Michael Blua and LCpl. Joshua Gomez
VMAQ-1**

While supporting 24-hour combat flight operations, Sgt. Blua and LCpl. Gomez were investigating engine irregularities on one of the squadron's EA-6B Prowlers. LCpl. Gomez was first to discover a small crack in the port inlet casing, which was visible only from inside the inlet. He suspected the crack would be larger underneath the surface. After NDI, the crack was found to be more than six inches long. Had the aircraft been flown, it is likely that catastrophic engine failure would have occurred from FOD.

Sgt. Blua was convinced the port engine still wasn't running properly, so he insisted on having the engine borescoped. His attention to detail paid off when the results showed a first-stage turbine stator had been burned away to less than half its normal size. Continued operation of this engine would have resulted in failure of the stator and possible FOD damage.
